Manhole Inspection Summary

Manhole # S04AA2015MH

Insp Date: **6/26/06 9:08 AM**

Location Address: **3608 CLARKS LN**

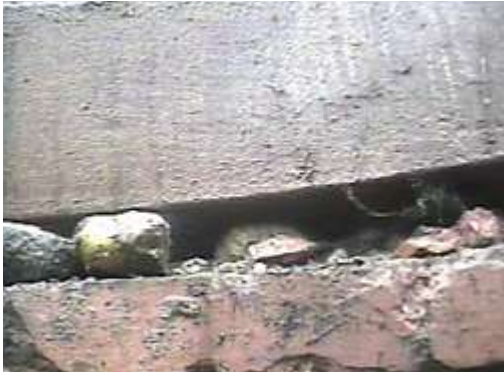
Defect

☒ **Leaks**

Condition: ☐ Sound ☐ Cracked ☐ Root Intrusion ☒ **Loose Brick** ☒ **Deteriorated**

Infiltration: ☐ None ☒ **Joint** ☐ Cracks ☐ Mortar ☐ Roots ☐ Wall

Frame leaks. Adjustment deterioration and loose brick. Adjustment infiltration.

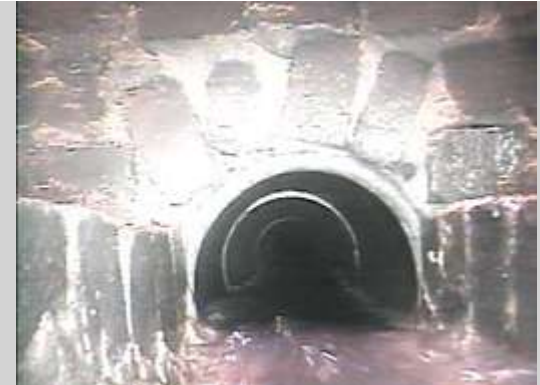
8 in. Circular Gravity Sewer Pipe Out @ 12 O'Clock

Infiltration: **Evidence** Pipe Seal Cond: **Unknown**

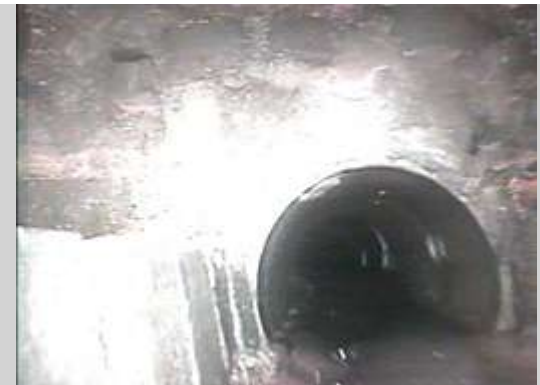
8 in. Circular Gravity Sewer Pipe In @ 6 O'Clock

Infiltration: **None** Pipe Seal Cond: **Unknown**
